[Problem to be Solved]

[Means for Solving the Problems]

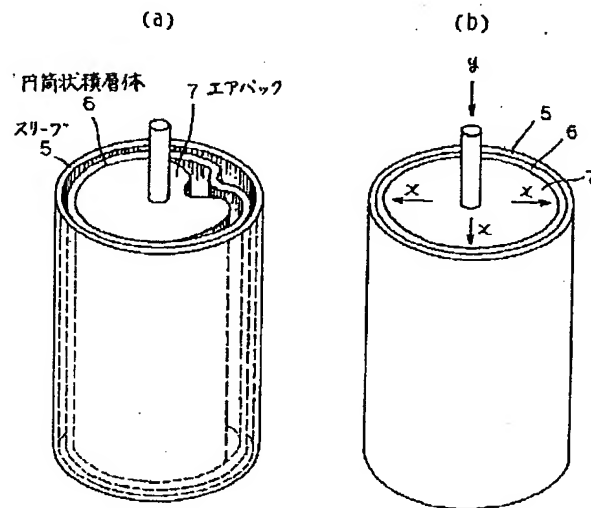
A cylindrical composite 6 consisting of a seamless core 4, a hot melt adhesive 3 and a cover material 2 is inserted in a space between an air bag 7 and a sleeve 5. Pressurized air is filled in the air bag 7 so as to press the cylindrical composite 6 against the inner wall of the sleeve 5. The cylindrical composite 6 is heated by a heating means so that the composite is adhered together by the melted hot melt adhesive 3. Cylindrical composite is cut into pieces so as to form conveyor belts.
